Facility: \NSA 1\Cabrillo Plgd

Facility: \NSA 1\Cabrillo Plgd\Cabrillo Park Site

Facility: \NSA 1\Cabrillo Plgd\Play Structure (Small)

Facility: \NSA 1\Cabrillo Plgd\Recreation Building

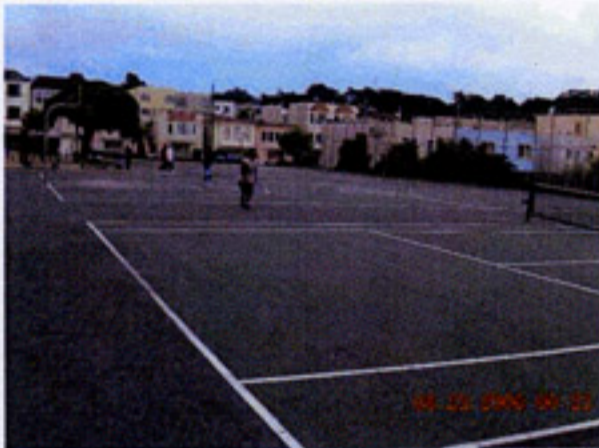
The playgrounds are not ADA compliant but are in generally good condition. There are 2 play areas, the area next the rec. room is smaller and has smaller structures. The majority of the equipment is made of wood and metal all anchored in a sand surface. Surround the play structure are cement steps to the rec. building and asphalt leading to the courts. The asphalt is broken and cracked and there are 2 tree wells missing tree. The courts are in acceptable condition and have a hard coat finish, they are approx. 27,254sft. The chain link fence surrounding the majority of the park is in need of replacement. There is approx. 4,000sft of maintained grass at the park, this includes the grass area along the sidewalks on 38th and 39th Ave.

Plumbing: The site contains one drinking fountain at entrance off 39th Avenue. The fountain is operation, but past useful life and non-ADA compliant.

Site drainage is through slope to street or (2) storm drains at South East corner of site. Storm drains appear clogged with stagnant water and past useful life.

Electrical: There is no site lighting.

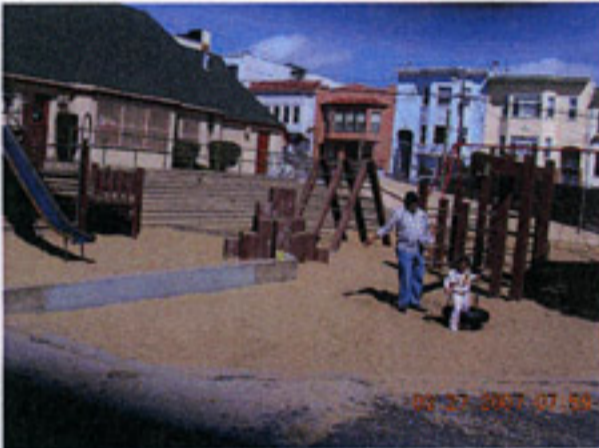
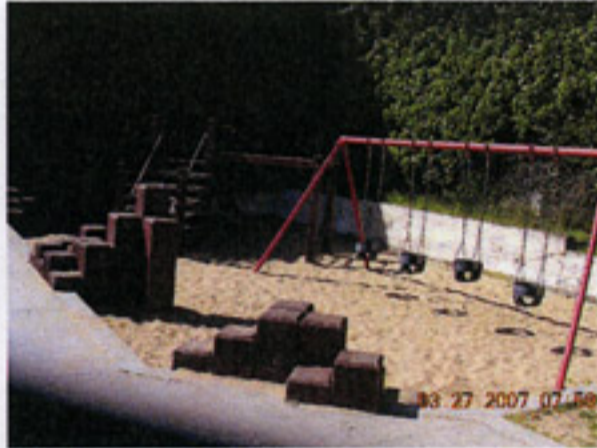
Play Structure: The play structures are wood frame with metal and wood elements. The ground surface is entirely sand. Estimate play area dated around 1960. While the play structures are in fair condition, they are currently non-ADA compliant. There is reasonable ADA access from the street provided minor improvements are made.

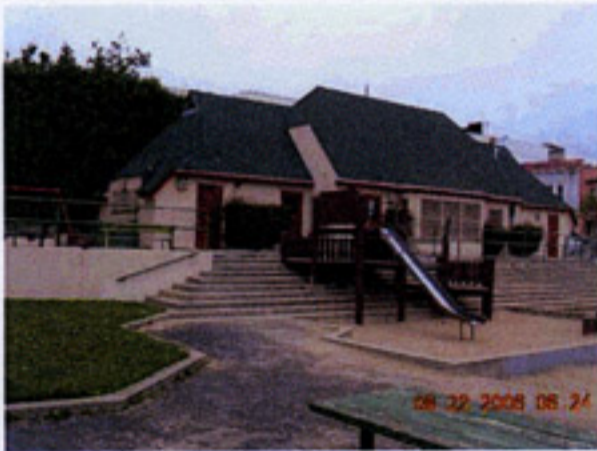
The exterior is a wood frame stucco building with a pitched roof and wood gutters, the exterior is in need of painting. Wood around bay window show signs of water damage and should be sanded down or replaced. Interior consist of a main room, kitchen, office and restroom in the building and a restroom on each side. The main room has cork floor with wood panels covering the walls and an exposed ceiling. The wood panels are in need of refinishing and the kitchen requires the cabinets to be refinished.

Mechanical: The building is heated by vertical gas fired furnace unit with distribution ductwork and local thermostatic control. We could not get the unit to operate, and grilles are very dirty. We did not have access to view the unit, so we are assuming past useful life. There is no mechanical cooling. Ventilation is provided by (2) wall mounted exhaust fans, appearing within 10 years of age. Clubhouse kitchen has gas stove with residential type hood. Stove, hood, and gas piping are past life.

Plumbing: Plumbing fixtures and piping are operational, but past useful life and non-ADA compliant. Gutters drain to storm drainage pipe, which is also past life.

Electrical: Power is fed from overhead lines to 100 amp main panel, 120/240 volt, which is dated 1989. Distribution assumed renovated at same time – 1989. Lighting is typically T-12 fluorescent with adequate illumination.

Life Safety: The building has no fire sprinklers or alarms systems.
