Facility: \NSA 1\Cabrillo Plgd

Facility: \NSA 1\Cabrillo Plgd\Cabrillo Park Site

Facility: \NSA 1\Cabrillo Plgd\Play Structure (Small)

Facility: \NSA 1\Cabrillo Plgd\Recreation Building

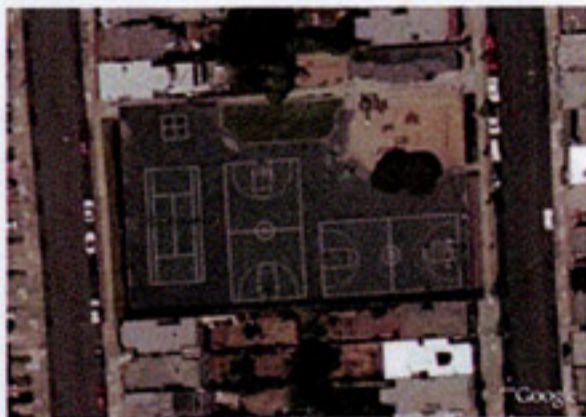
This is a mixed use area located between Cabillo St. and 39th Ave, there are tennis and basketball courts, 2 children's play areas, a club house and a Conex box for storage. The club house is a 1,274 sf building and the park is approx. 43,116 sf. The park was constructed in 1930 and updated in 1983.
